A Watershed Conditions Report For the State of Kansas HUC 10260015 (Solomon River) Watershed

Watershed Conditions Report For HUC 8 10260015 (Solomon River)

Prepared by
Kansas Department of Health and Environment (KDHE)
Nonpoint Source Section
05/16/01

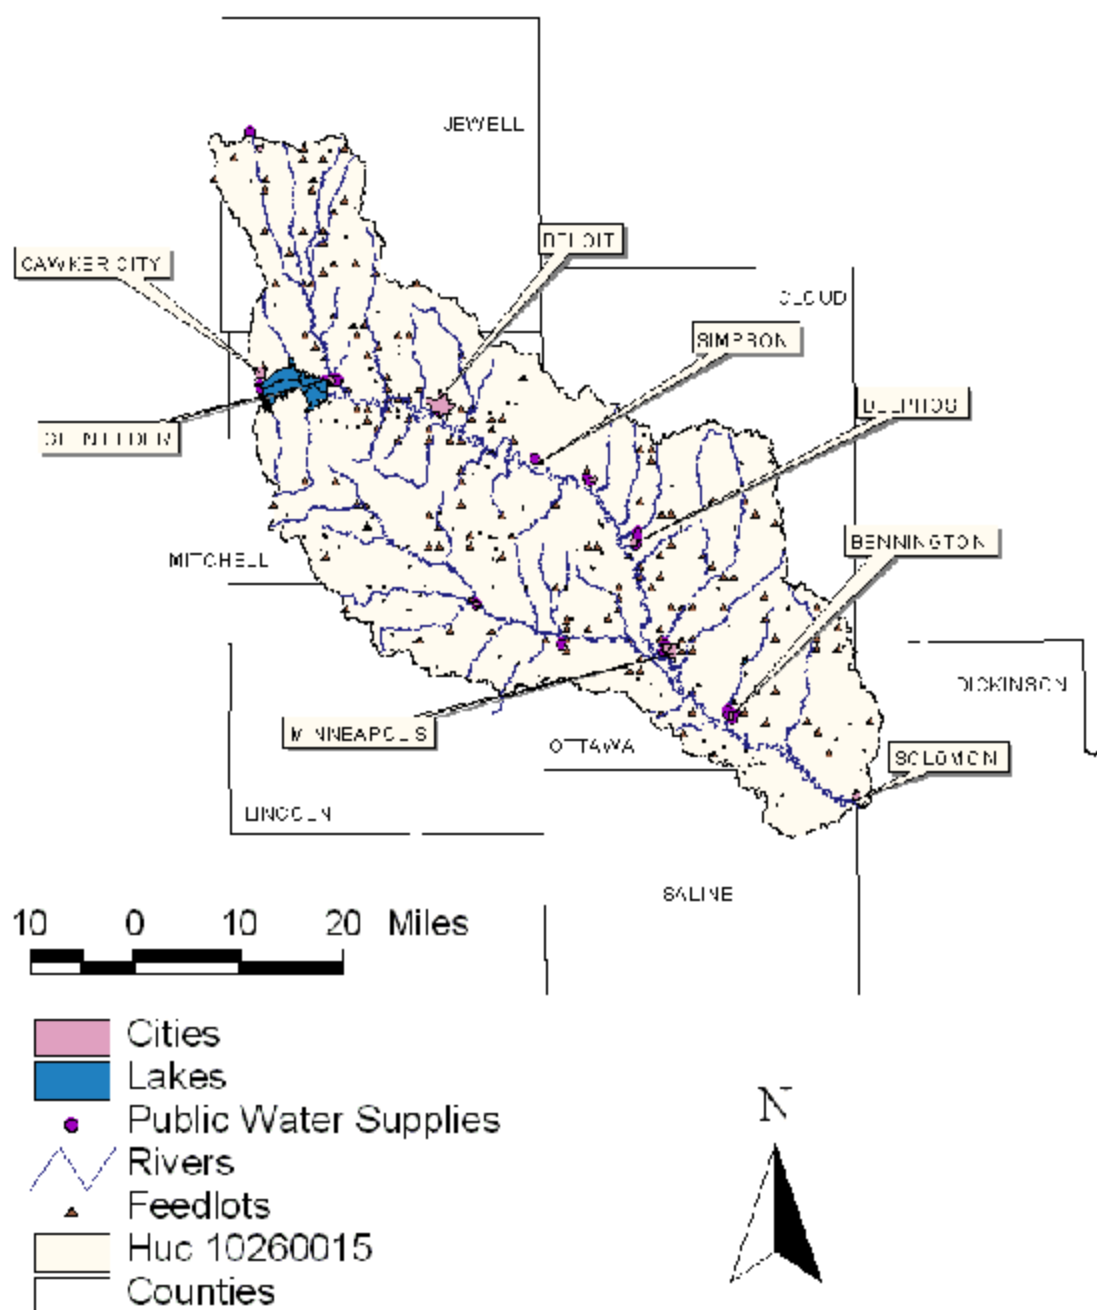
Huc 10260015 -Solomon River Watershed Boundary
